Subject: Transmission Fluid Leak Near Torque Converter Housing Area

This bulletin only applies to 8T65/45 or 9T45/50/60/65 transmissions.

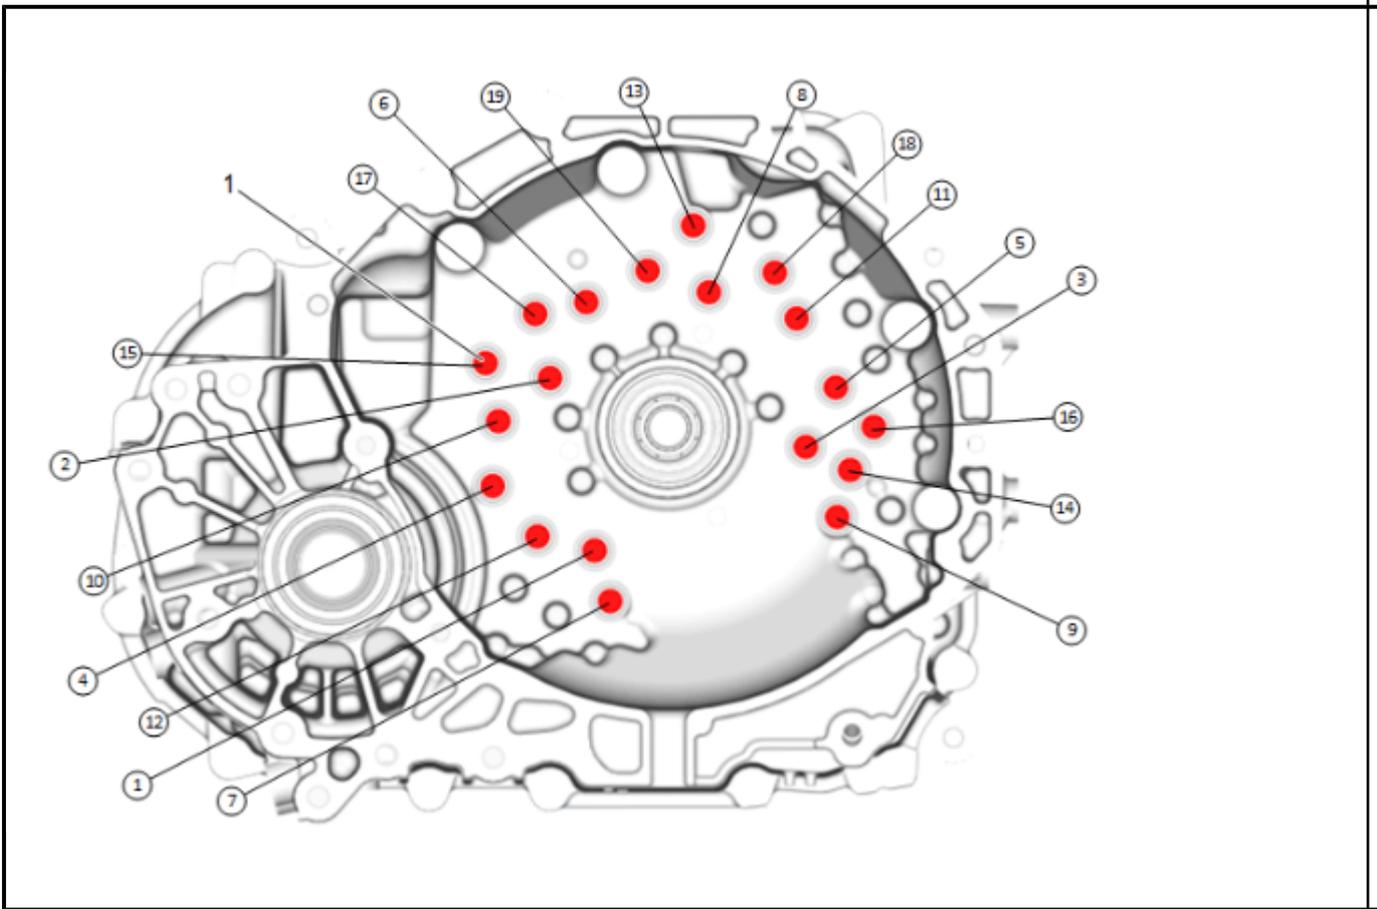
6419117

In-volved Re-gion or Coun-try	North America, Japan, South Korea, Europe, Palestine, Middle East, Chile, Brazil, Colombia.
Con-di-tion	Some customers may comment on a transmission fluid leak. Some technicians may comment on a transmission fluid leak coming from the torque converter housing.

This condition may be caused by the transmission pump bolts were not fully torqued.

- If the transmission Julian date is between 24 160 and 24 311 and the vehicle comes in with a transmission leak in the torque converter housing area, order the bolt kit as required.

- Once the bolt kit arrives, remove the transmission, and verify that the bolts are loose.
- If loose, replace all the bolts and reinstall the transmission.

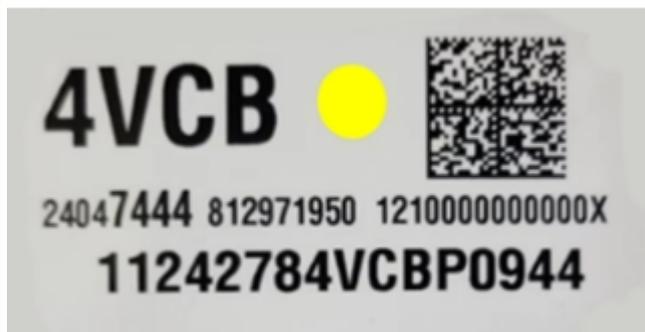
6863024

Note: Service replacement transmission assemblies received may be built in the same Julian date range. If that occurs check the transmission label for a Yellow Dot on it.

If a Yellow Dot is seen the pump bolts have already been replaced and no further action is required.

If **No** Yellow Dot is seen and the transmission is built in the Julian date range, then the pump bolts must be replaced before the transmission is installed into the vehicle.
